# Äerdschëff

## Building technical dossier

Design, systems, operation and available knowledge

Version 1.1 · 14 September 2026 · English edition

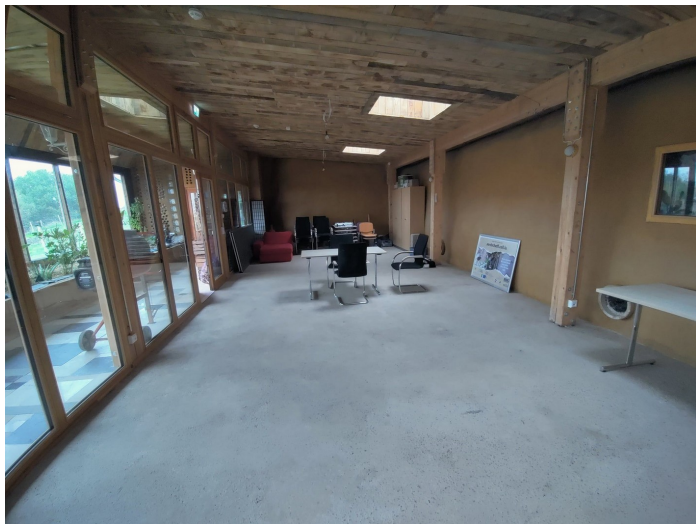
Activity room: windows and doors, materials and interior layout. Photographic archive from the MENJE dossier, filed in the 2022 monitoring collection [M14].

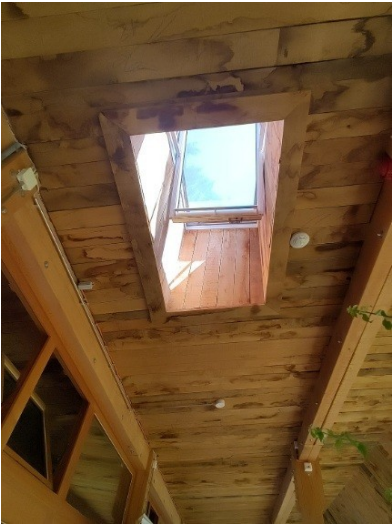
Roof opening, EuroSolar photograph [E, p. 8].

The principle combines high greenhouse openings, connections to the rear rooms and buried ducts. Removing warm air encourages air intake through the ducts. These descriptions explain intended operation, not measured flow rates. [E, p. 7]

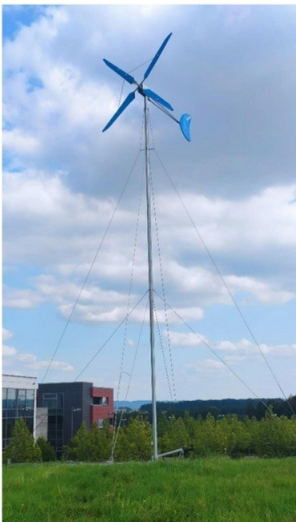
Wind turbine illustrated in EuroSolar [E, p. 5].

The Drive dossier supplies no manufacturer wind-turbine power curve, separate wind-production series, wind measurement at the rotor or final single-line diagram. Drawings show installations and indicative routes, not these operational data.

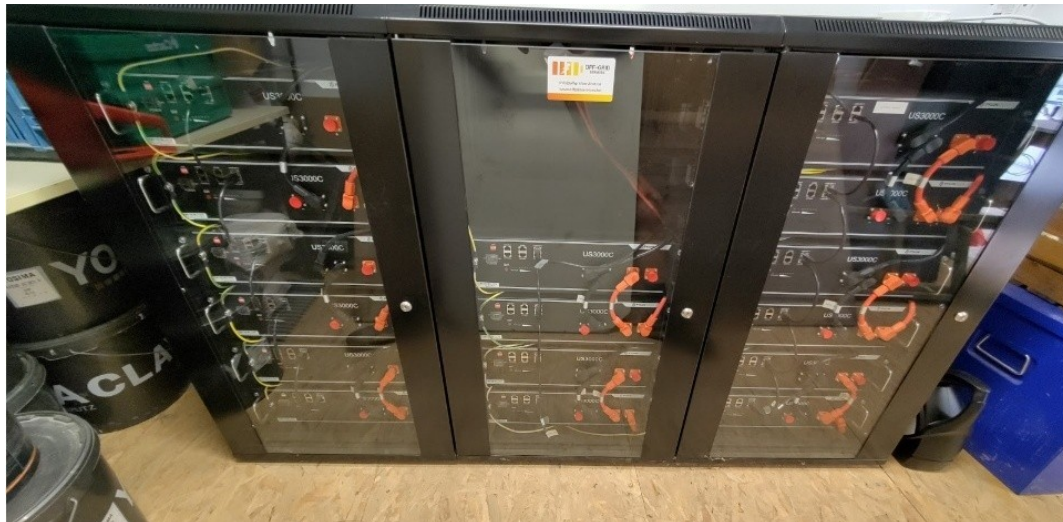
Battery bank, EuroSolar photograph [E, p. 5]. The technical sheet remains the reference for the count.

The reference configuration is EuroSolar's numerical sheet: 16 Pylontech US3000 LiFePO4 modules, with a stated total capacity of 56.8 kWh. Other battery accounts are not used to redefine this installation. [E, p. 4]

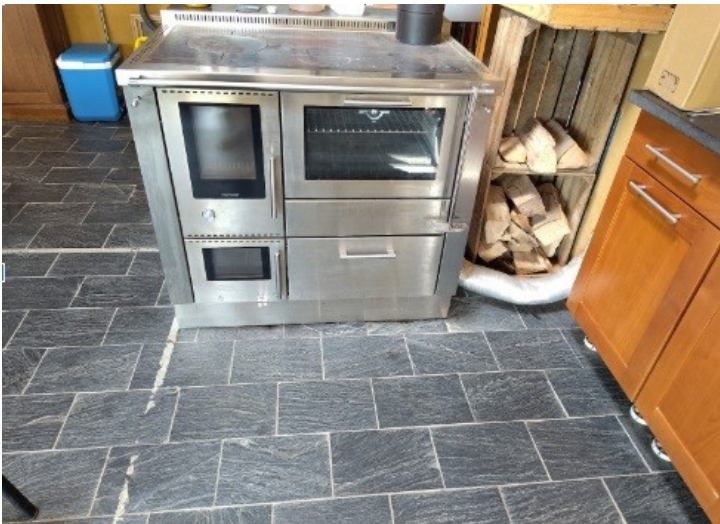
Cooking stove documented in EuroSolar [E, p. 8].

| Equipment | EuroSolar characteristic |
|---|---|
| Wood backup | Boiler/cooking stove rated at 10 kW. |

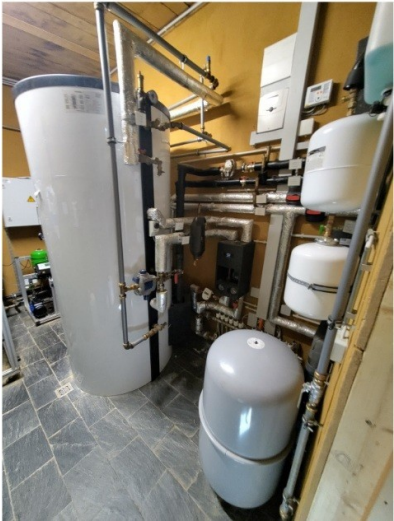
Treatment installation, EuroSolar photograph [E, p. 9].

Roof water is collected and stored in an approximately 30 m³ system. The 2019 plan shows three 10,000 L cisterns; the manuscript also describes three tanks behind the building. This agreement clarifies EuroSolar's total storage figure. [E, p. 4, 9; P02; O, p. 19]
